Arroyo Mocho Boulder Removal Project: Lawrence Livermore National Laboratory Hetch Hetchy Pump Station

July 24, 2007

BIOLOGICAL ASSESSMENT

ARROYO MOCHO BOULDER REMOVAL PROJECT: LAWRENCE LIVERMORE NATIONAL LABORATORY HETCH HETCHY PUMP STATION

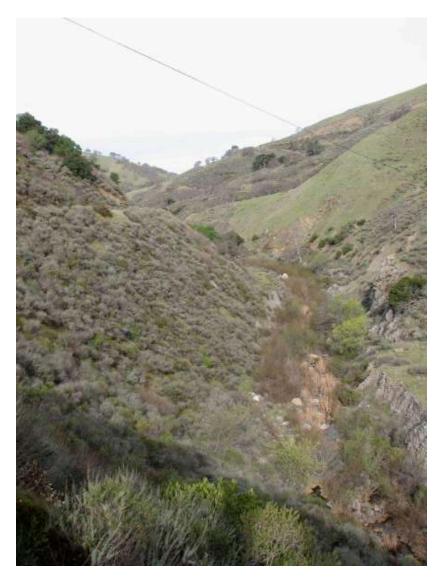
Photo 1. Steep slopes and a medium to high gradient stream course characterize Arroyo Mocho, downstream of the pump station. The streambed includes angular cobble and boulders and to a lesser extent gravel and sand. A relict terrace of excavation spoils can be seen in the photo on the right bank and then on the left bank. The stream has cut through the spoils and stabilized at its current elevation.

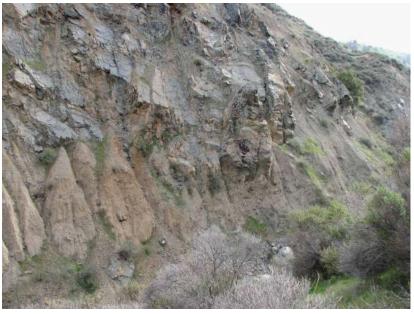
Photo 2. The north bank of Arroyo Mocho at the pump station is a steep, 100-200 foot slope that is actively eroding and periodically releases large boulders into Arroyo Mocho. This photo was taken from the concrete apron of the Arroyo Mocho pump station on April 27, 2007.

At the project site, the steep canyon walls of Arroyo Mocho are actively eroding (north side) resulting in periodic release of large boulders into the active channel of Arroyo Mocho. These boulders re-direct stream flow, especially during high flow events. Currently, two boulders that measure approximately 5-feet by 8-feet are directing seasonal high flows into the gabion retaining wall (south side) and concrete footing at the base of the slope supporting the pump station (Appendix 2). According to LLNL's consulting geotechnical firm, high flows directed into the gabion wall could threaten the integrity of the overall structure and put the pump station at risk. Failure of the pump station would have catastrophic effects on the stream and surrounding habitat, and eliminate the primary water source for LLNL's Livermore Site and Sandia National Laboratory.

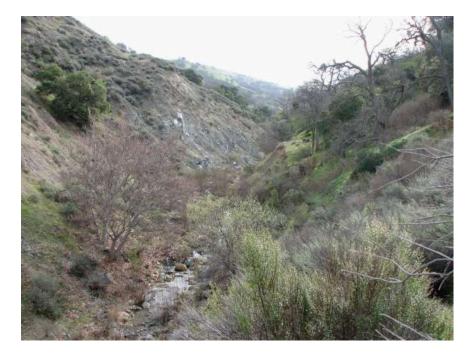
Photo 3. Arroyo Mocho upstream of the pump station has streambed morphology similar to below the pump station; however, it doesn't contain a spoils terrace. Similar to the project area in Photo 2, the north/right bank of Arroyo Mocho is also actively eroding as shown in this photo.

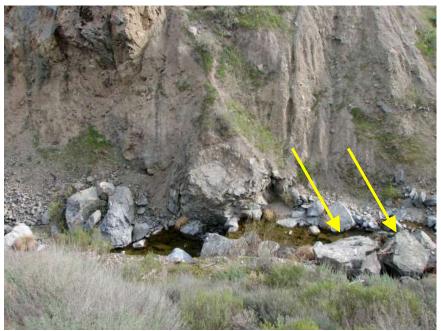
Photo 4. The intent of the project is to disaggregate the two boulders (yellow arrows) and relocate the fragments out of the active flow path of Arroyo Mocho. During high flow events, water is deflected by the boulders into and on top of the gabion wall that protects the toe of the slope that supports the pump station. Immediately below the two target boulders is the narrowest point on Arroyo Mocho and the gabion wall. Photo was taken from the pump station apron on April 27, 2007.

Hydraulic splitting is the demolition method proposed to disaggregate the boulders shown in Appendix 2, Photos 4-5. The boulders will be broken by first drilling 1 ¾-inch diameter holes in the rock to a depth to be determined in the field. The hand-held drill will either be electric or a gas powered rotary hammer drill. Once the holes are drilled, the hydraulic splitters (e.g., cylinder) will be inserted into the holes and the splitters will be connected to the pump. The pump will either be electric, pneumatic, or gas powered. A complete system consists of a cylinder, 30 feet of high and low pressure hoses, high and low pressure whips, quick connect couplings, a hydraulic pump, and lubricant. While the exact make and model of the hydraulic splitting unit is yet to be determined, information on hydraulic splitting can be viewed on the Internet at http://www.elco.com/splitter.htm. No modification to upland habitat, vegetation removal, or the existing infrastructure is proposed. A crew of three or four individuals from LLNL's Labor Shop will do the work. The total project footprint centered on the two boulders is approximately 25-feet by 25-feet. The process of splitting the boulders and moving the boulder fragments by hand is expected to take approximately 3 to 5 days, depending on the number of boulders present in any given year.

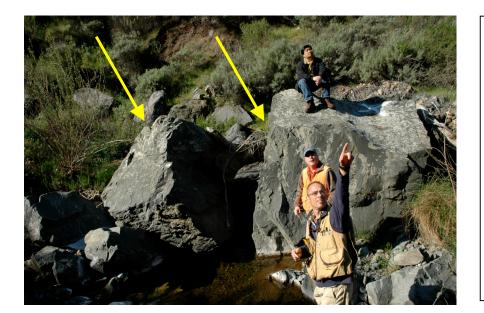
Photo 5. The two boulders (yellow arrows) are shown with engineer and geologists for scale.

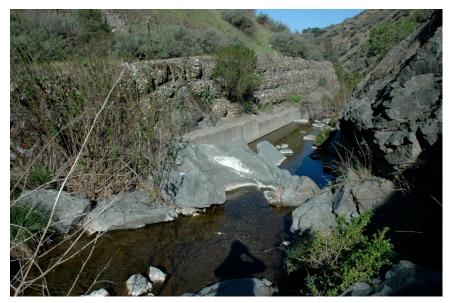
Photo 6. The gabion wall and concrete footing, as shown, protects the toe of the slope supporting the pump station.
